Inspection Report

John Doe
4458 Alton Parkway
Arlington, TX 76006

PROPERTY INSPECTION REPORT

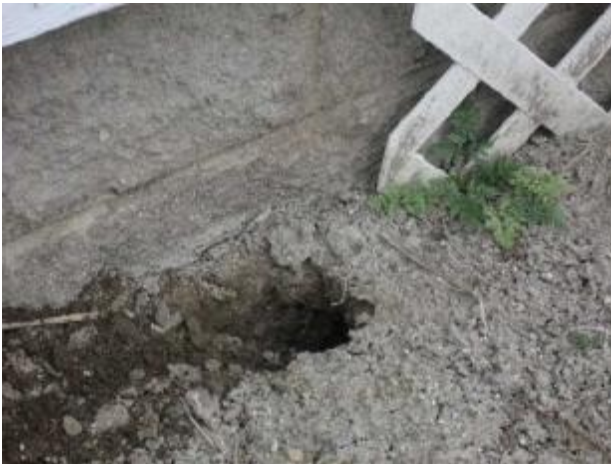
IA3

Numerous chipmunk tunnels located around foundation. Recommend that professional pest control operator be contacted to remove chipmunks to prevent damage from moisture incursion under slab (see photo IA1).

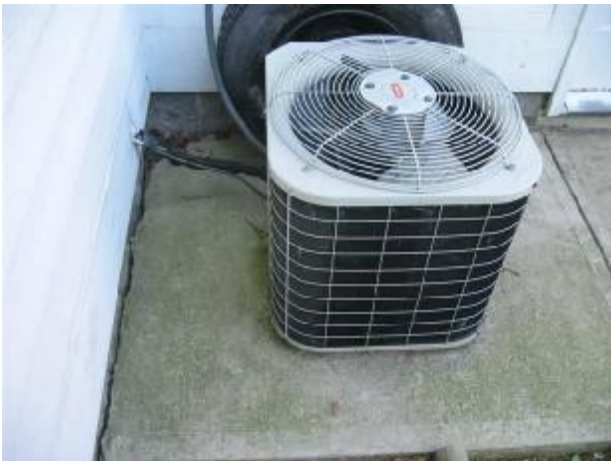
IB5

Numerous chipmunk tunnels around foundation permitting water to accumulate under the slab. Recommend that licensed pest control professional be consulted on best way to address chipmunk issue (see photo IB1).

Numerous chipmunk tunnels around foundation permitting water to accumulate under the slab. Recommend that licensed pest control professional be consulted on best way to address chipmunk issue (see photo IB1).

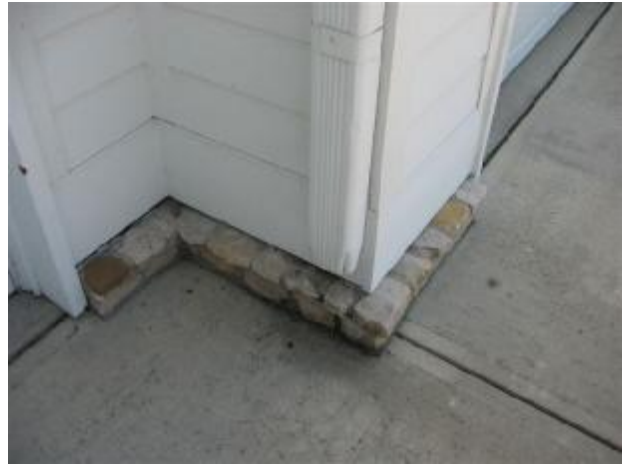
I12

Elbow missing from the north side of double vehicle door (see photo ID12)
